## SO WHAT'S SPECIAL ABOUT WORTLEY?

David Wilson

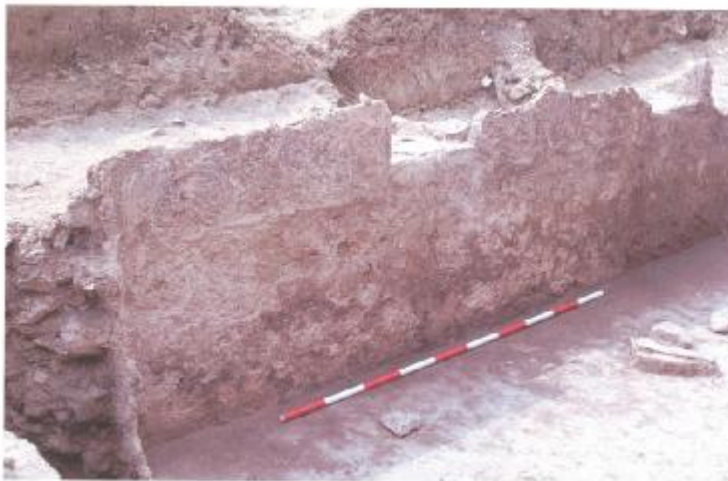
Fig. 1 Niches in the southern wall of the cellar

Cellars on Romano-British sites are commonly seen as storage areas; they are relatively rare in Roman Britain, and their construction is mainly restricted to the period AD70-155. But the cellar at Wortley was, in origin, not a simple storage facility, but an underground cult room. The evidence for this special use is fourfold. First, the walls had been decorated by coloured painting rather than the plain whitewash of a storage room. Second, the southern wall had niches in it which may have held cult images (Fig. 1).

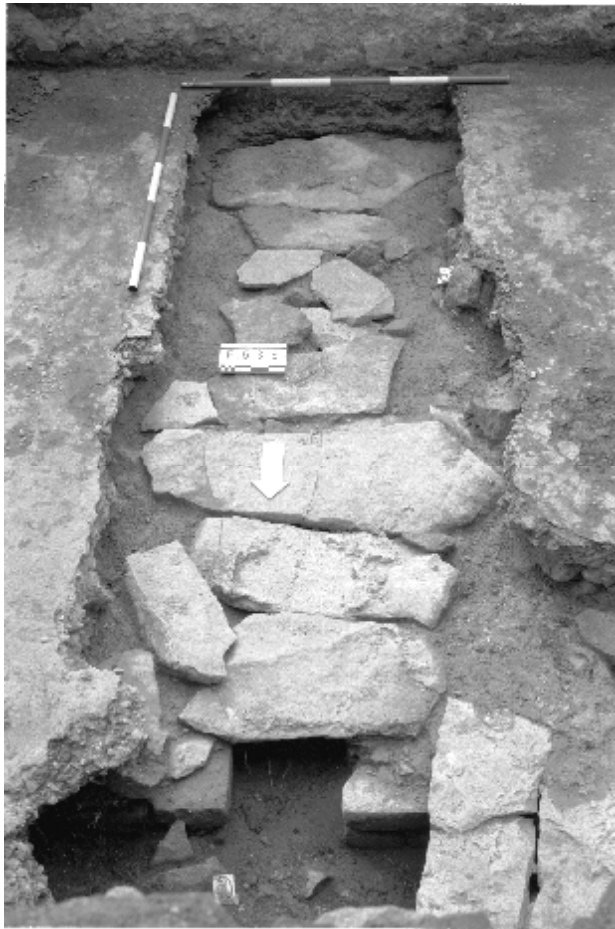
Fig. 2 Capstones over the southern channel beneath the cellar floor

half of the cellar not available for excavation. Each of these channels was covered by capstones mortared onto the stone edges of the channels (Fig. 2), and over time the channels had become filled with clay (Fig. 3).

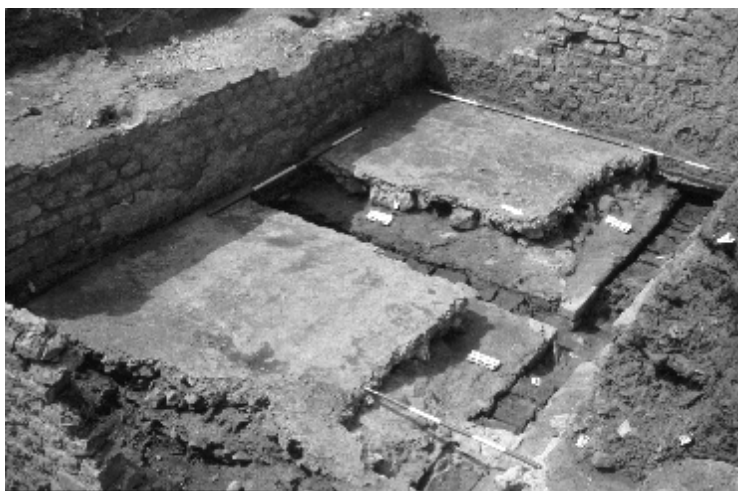
Fig. 3 Clay-filled channels beneath the cellar floor

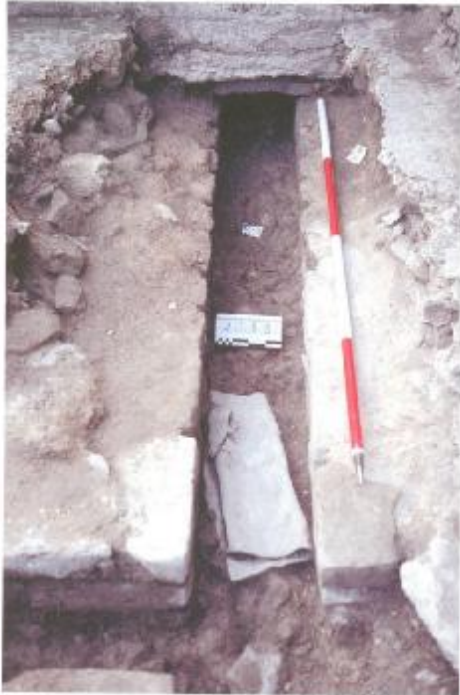
Fig. 4 One of the folded pieces of lead in situ in the western channel

The most surprising aspect, however, was that all three complete channels ran beneath the walls of the cellar, under rough stone lintels, but ended at the outer limits of the walls. Consequently, they were not part of any drainage system, but were associated solely with the cellar. We can't be sure of the function of these channels, but two large, folded pieces of lead found in the western channel (Fig. 4) may have formed the lining for a font-like feature set within a hole found in the centre of the concrete floor, immediately above the junction of the channels.

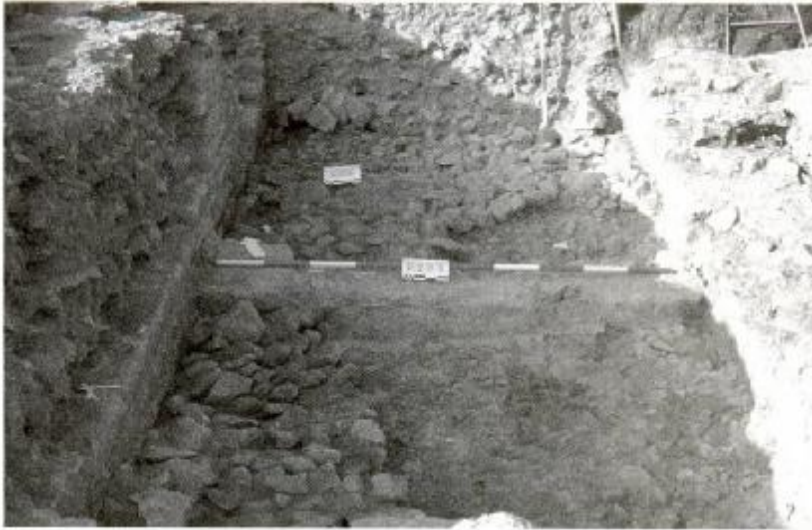
Fig. 5 Damaged walls and floor of natatorium

That'll do then for the first unique aspect of the Wortley site. Let's turn now to the bathhouse. The first striking thing about it was its size: just under fourteen metres in length and comprising six areas, ranging from a hot room to a latrine. And included in these six is something even more striking: a natatorium or swimming pool, some 13.7 metres long and 2.2 metres wide internally. No prizes for a Romano-Briton swimming a width, but good for up-and-down work! Such a pool is extremely rare outside of large urban sites, and would seem to be the largest of any known on a rural site. So the presence and size of the Wortley natatorium is remarkable, but there is another rare, if not unique aspect. There was no evidence of any non-porous lining to the surface or the walls of the pool, and so it seems that it took the form of a large lead tank sitting upon a pitched stone surface. The inner faces of the two north-south walls were badly damaged, suggesting the vigorous removal of such a tank (Fig. 5). Interestingly, the cold plunge bath showed a similar lack of non-porous lining to its floor and what remained of its walls, again pointing to the use of lead to provide a 'tank'.
